**Flood Control Project Maintenance  
Levee Inspections**

**Fall 2014 Levee Maintenance Deficiency Summary Report**

**Sacramento River Basin**

**Reclamation District No. 0787 Fair**

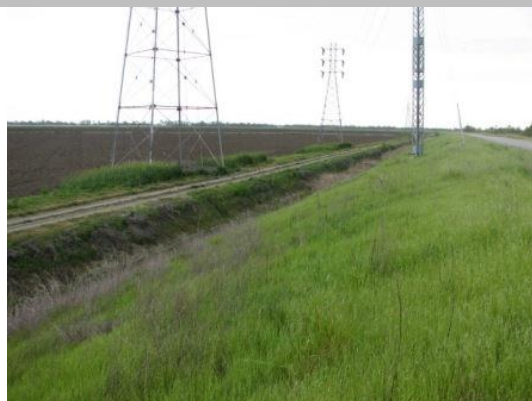
Photo 1 of 3 : FA\_2014\_RD0787\_212\_13\_20141014\_00004.jpg

LM Start	1.57	Rating **	M	Issue No.	13
LM End	2.71	Issue Type +	En	Location *	LS
Category	Earthen Levee			GPS Latitude/Longitude	
				Start	End
Item	Encroachments			38.801794 °	38.809506 °
				-121.750204 °	-121.768979 °
DWR ID	DWR_RD0787_01_s_2012_13				
Action/Comments					
Ditch

Agricultural ditch runs along landside the distance of the district.

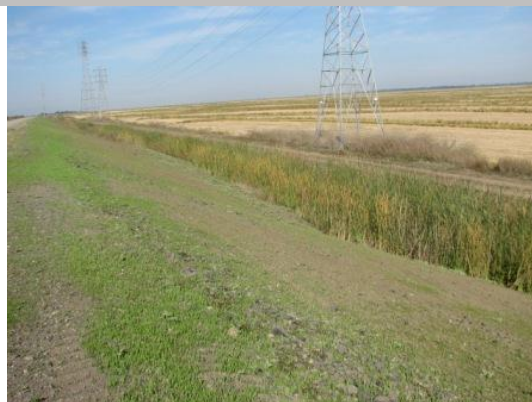
Photo 2 of 3 : FA\_2014\_RD0787\_212\_13\_20141014\_00005.jpg

A view of the agricultural ditch in the fall of 2011.

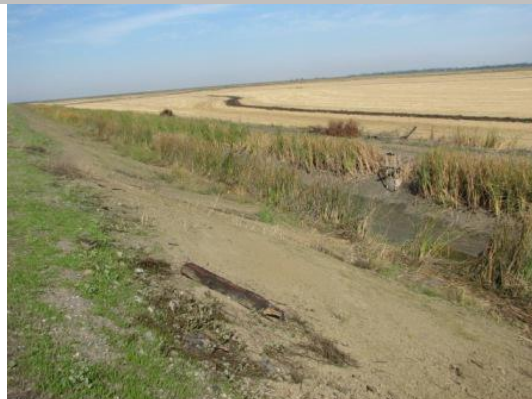
Photo 2 of 3 : FA\_2014\_RD0787\_212\_14\_20141014\_00008.jpg

LM Start	3.11	Rating **	M	Issue No.	14 (cont)	
LM End	4.37	Issue Type +	En	Location *	LS	
Category	Earthen Levee			GPS Latitude/Longitude		
				Start		End
Item	Encroachments			38.812963 °		38.822302 °
				-121.774880 °		-121.795295 °
DWR ID	DWR_RD0787_01_s_2012_14					
Action/Comments						
Ditch

A current view of the agricultural ditch photo taken in fall of 2011.

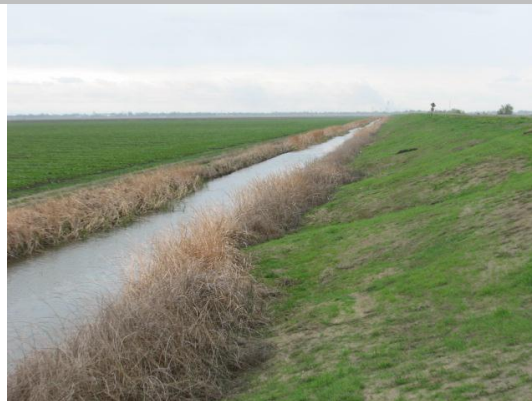
Photo 3 of 3 : FA\_2014\_RD0787\_212\_14\_20141014\_00009.jpg

The agricultural ditch runs along the toe of the levee slope. Spring 2014
